A to Z Home Inspections

Property Address	332 W Main Street Springfield, MO
Approximate Year Built	1983
Approximate Square Footage	1,500
Number of Bedroom/Bath	3/2
Direction House Faces	East

Report Summary Page

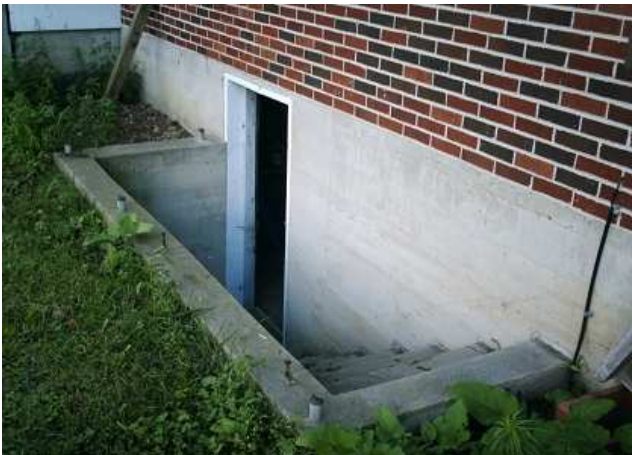
3.1.4 Rear Entrance Conditions SA Comments: The basement steps were missing a safety rail. This is a safety hazard because someone may fall if they don't see the drop off. It is recommended that a handrail be added, contact a general contractor for repair.

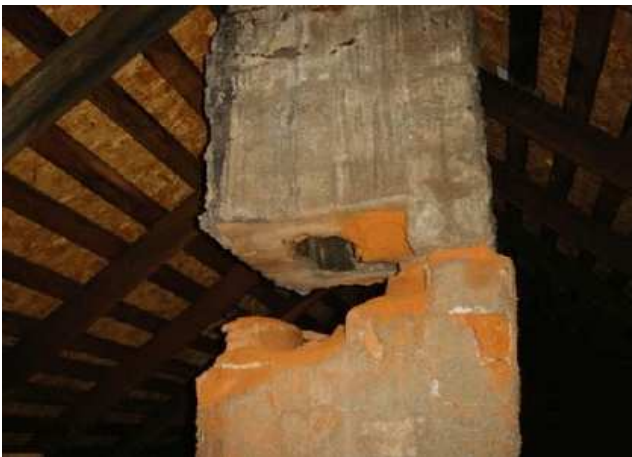
4.2.2 Chimney Condition SA Comments: The chimney was badly deteriorated in the attic area. This may pose a fire hazard and has the potential to collapse and cause damage to the home or injury to occupants. It is recommended a general contractor be contacted for repair.

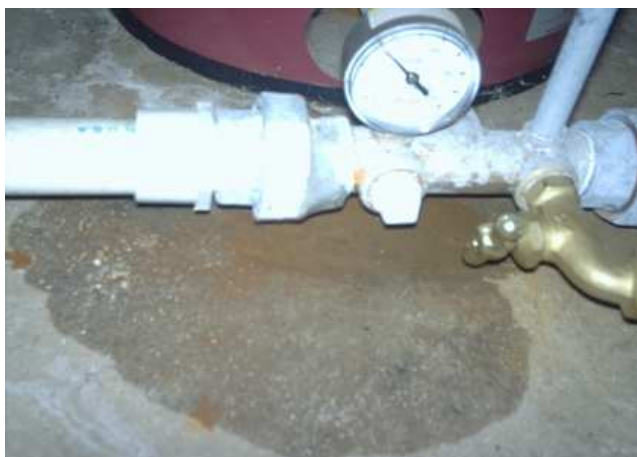
7.1.3 Main Line & Valve Conditions NR Comments: There was a leak in the main line near the well tank in the basement. It is recommended that a plumber be contacted for repair.
